2023 OSIM Bridge Inspections Report

**Town of Grand Valley
5 Main Street North
Grand Valley, ON L9W 5S6**

**October 2023
30053109.2023**

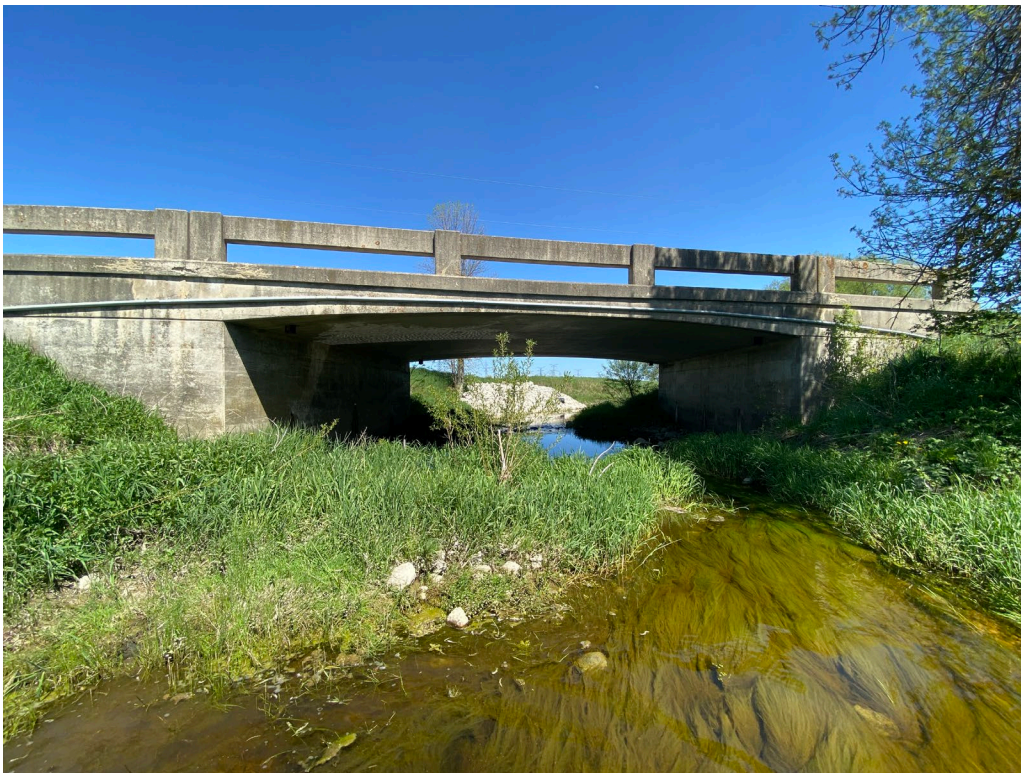
1.4 Structure No. 04

<u>Structure Name:</u>	Bridge No. 4	2023 BCI =71.07
<u>Road Name:</u>	Sideroad 24-25	
<u>Location:</u>	0.5 km South of County Road 15 (Concession X, Lot 24/25)	
<u>Structure Type:</u>	Cast-In-Place Conc. Rigid Frame	
<u>Number of Spans:</u>	1	<u>Span Lengths:</u> 10.6 m (11.05 m skew span) m
<u>Overall Structure Width:</u>	9.8 m	<u>Roadway Width:</u> 8.6 m
<u>Year of Construction:</u>	1955	<u>Current Load Limit:</u>

Recommendation:	Minor Rehabilitation is recommended within 3 years.
------------------------	--

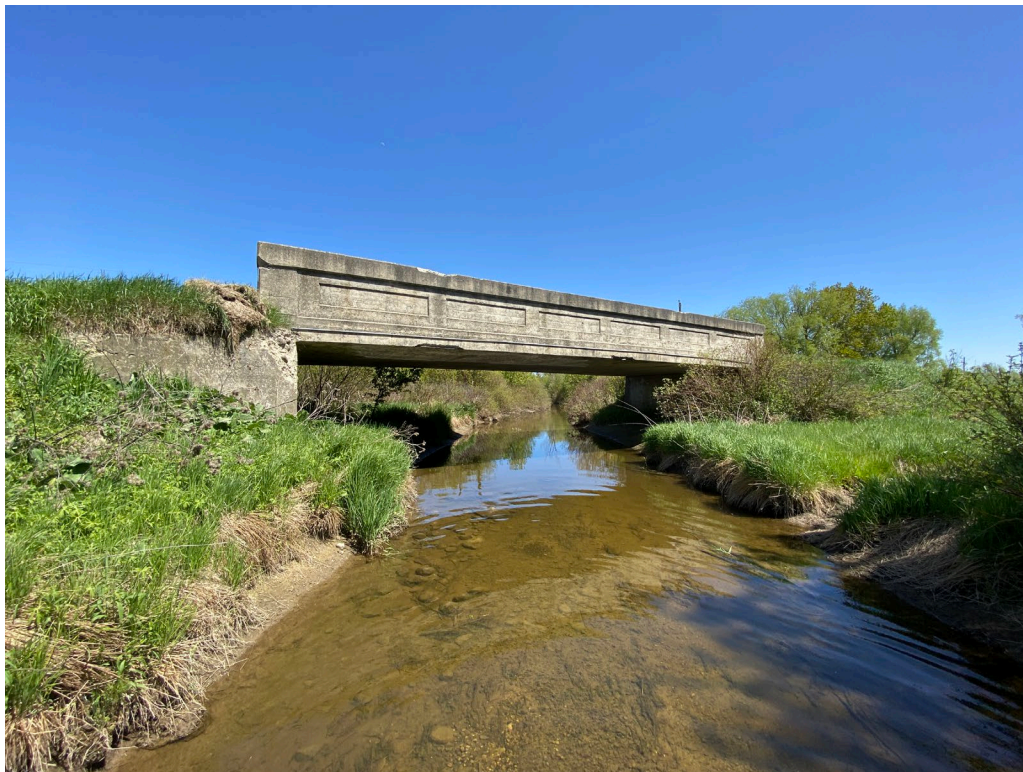
1.7 Structure No. 07

During the 2023 inspections, Bridge 07, located on Sideroad 24-25, was noted to be in fair to poor condition with severe deterioration to the deck. If this structure is not replaced in the near future, given the condition of the deck, it is recommended that a structure evaluation be completed (if existing drawings are available) to determine the required load posting.

<u>Structure Name:</u>	Bridge No. 7	2023 BCI =53.51
<u>Road Name:</u>	Sideroad 24-25	
<u>Location:</u>	0.3km south of Concession Road 8-9 (Conc. VIII, Lot 24/25)	
<u>Structure Type:</u>	Through Girder (Concrete)	
<u>Number of Spans:</u>	1	<u>Span Lengths:</u> 15.15 m
<u>Overall Structure Width:</u>	6.5 m	<u>Roadway Width:</u> 4.9 m
<u>Year of Construction:</u>	1920	<u>Current Load Limit:</u>

Structure No.	Load Posting (tonnes)	Recommendations
07	To be determined	If the structure is not replaced in the near future, it is recommended that a load limit should be determined based on condition of structure and vehicle weights used at time of design of this bridge.

Recommendation:	Forgo rehabilitation and replace structure within 2 years.
------------------------	---

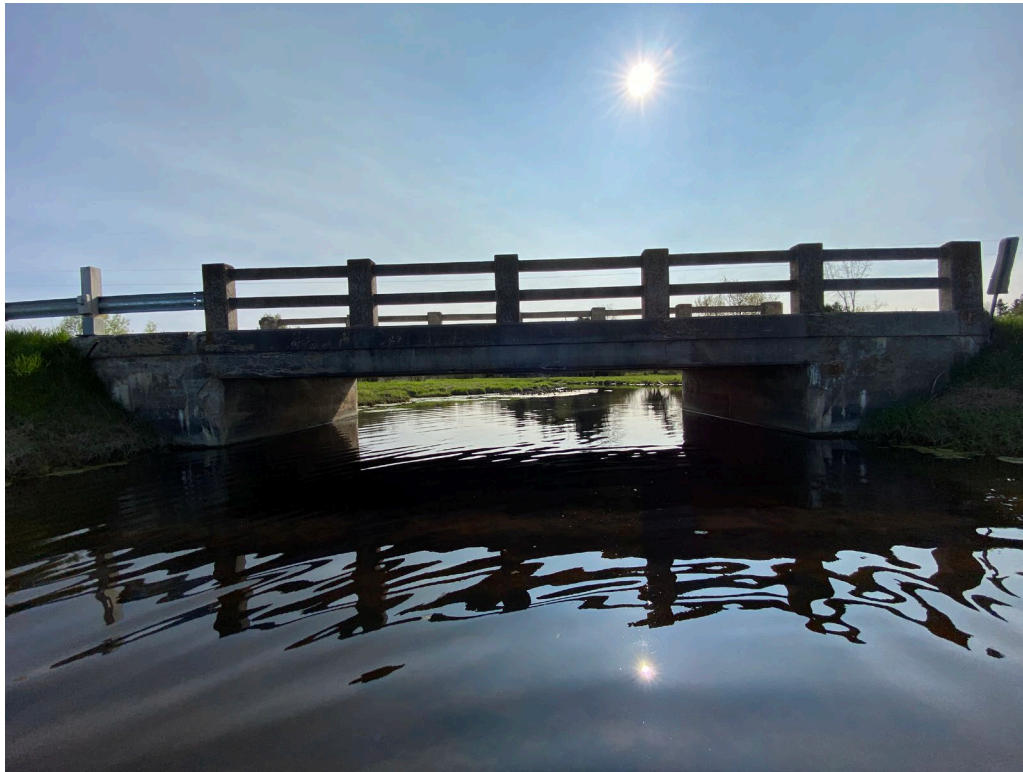
1.10 Structure No. 10

<u>Structure Name:</u>	Bridge No. 10	2023 BCI =59.21
<u>Road Name:</u>	Sideroad 27-28	
<u>Location:</u>	1.75km north of County Rd. 15 (Conc. XII, Lot 27/28)	
<u>Structure Type:</u>	Cast-In-Place Concrete T-Beam	
<u>Number of Spans:</u>	1	<u>Span Lengths:</u> 9.8 m
<u>Overall Structure Width:</u>	5.8 m	<u>Roadway Width:</u> 4.9 m
<u>Year of Construction:</u>	1965	<u>Current Load Limit:</u>

Recommendation:	Forgo rehabilitation and replace structure within 2 years.
------------------------	---

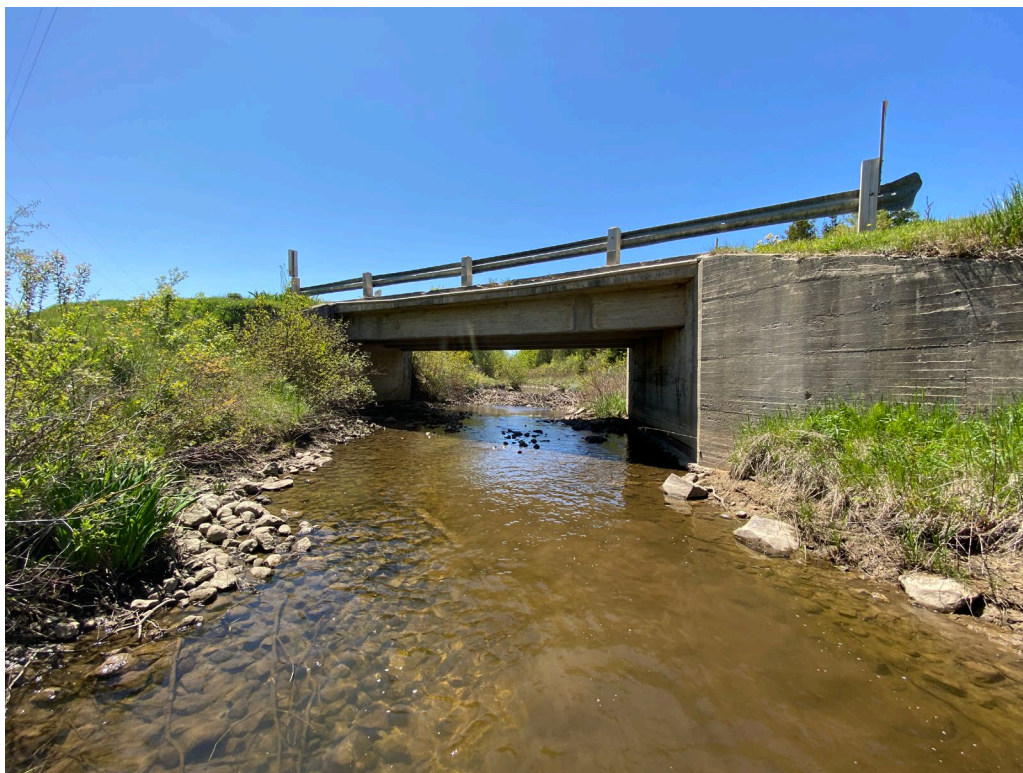
1.14 Structure No. 14

<u>Structure Name:</u>	Bridge No. 14	2023 BCI =61.01
<u>Road Name:</u>	Sideroad 21-22	
<u>Location:</u>	1.1km north of Concession Road 8-9 (Conc. IX, Lot 21/22)	
<u>Structure Type:</u>	Cast-In-Place Concrete T-Beam	
<u>Number of Spans:</u>	1	<u>Span Lengths:</u> 9.2 m (10.6 m skew span) m
<u>Overall Structure Width:</u>	5.8 m	<u>Roadway Width:</u> 4.9 m
<u>Year of Construction:</u>	1970	<u>Current Load Limit:</u>

Recommendation: Forgo rehabilitation and replace structure within 6 years.
