Arborist Report: 20 Scott St, Grand Valley

Prepared for Daniel Hrycyna

February 21st, 2019

North-South Environmental Inc.

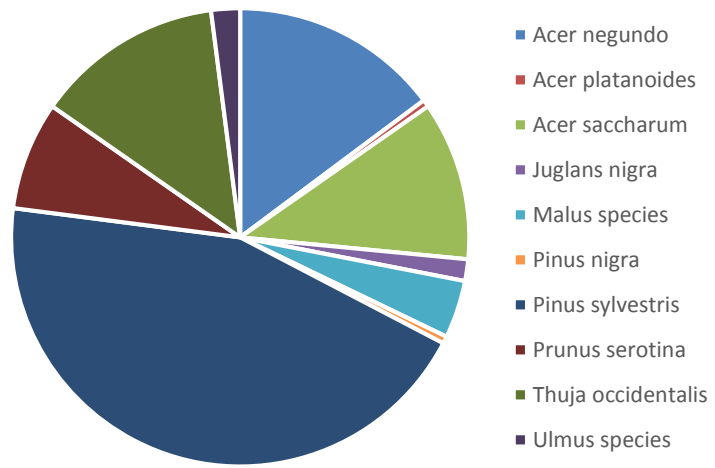
Figure 1: Tree diversity at 20 Scott Street

This tree inventory surveyed a total of 196 trees. Majority of the trees surveyed were in excellent health (Class 1), Table 1. Four (4) non-native species were inventoried: Norway Maple (*Acer platanoides*), Apple species (likely *Malus pumila*), Austrian Pine (*Pinus nigra*), and Scots Pine. One species, Manitoba Maple (*Acer negundo*) is native to parts of Ontario but readily spreads and is considered invasive in some locations and contexts. The most common species inventoried was Scots Pine (Figure 1), which is not surprising as the subject property is dominated by Scots Pine plantation. No species at risk were found on site.

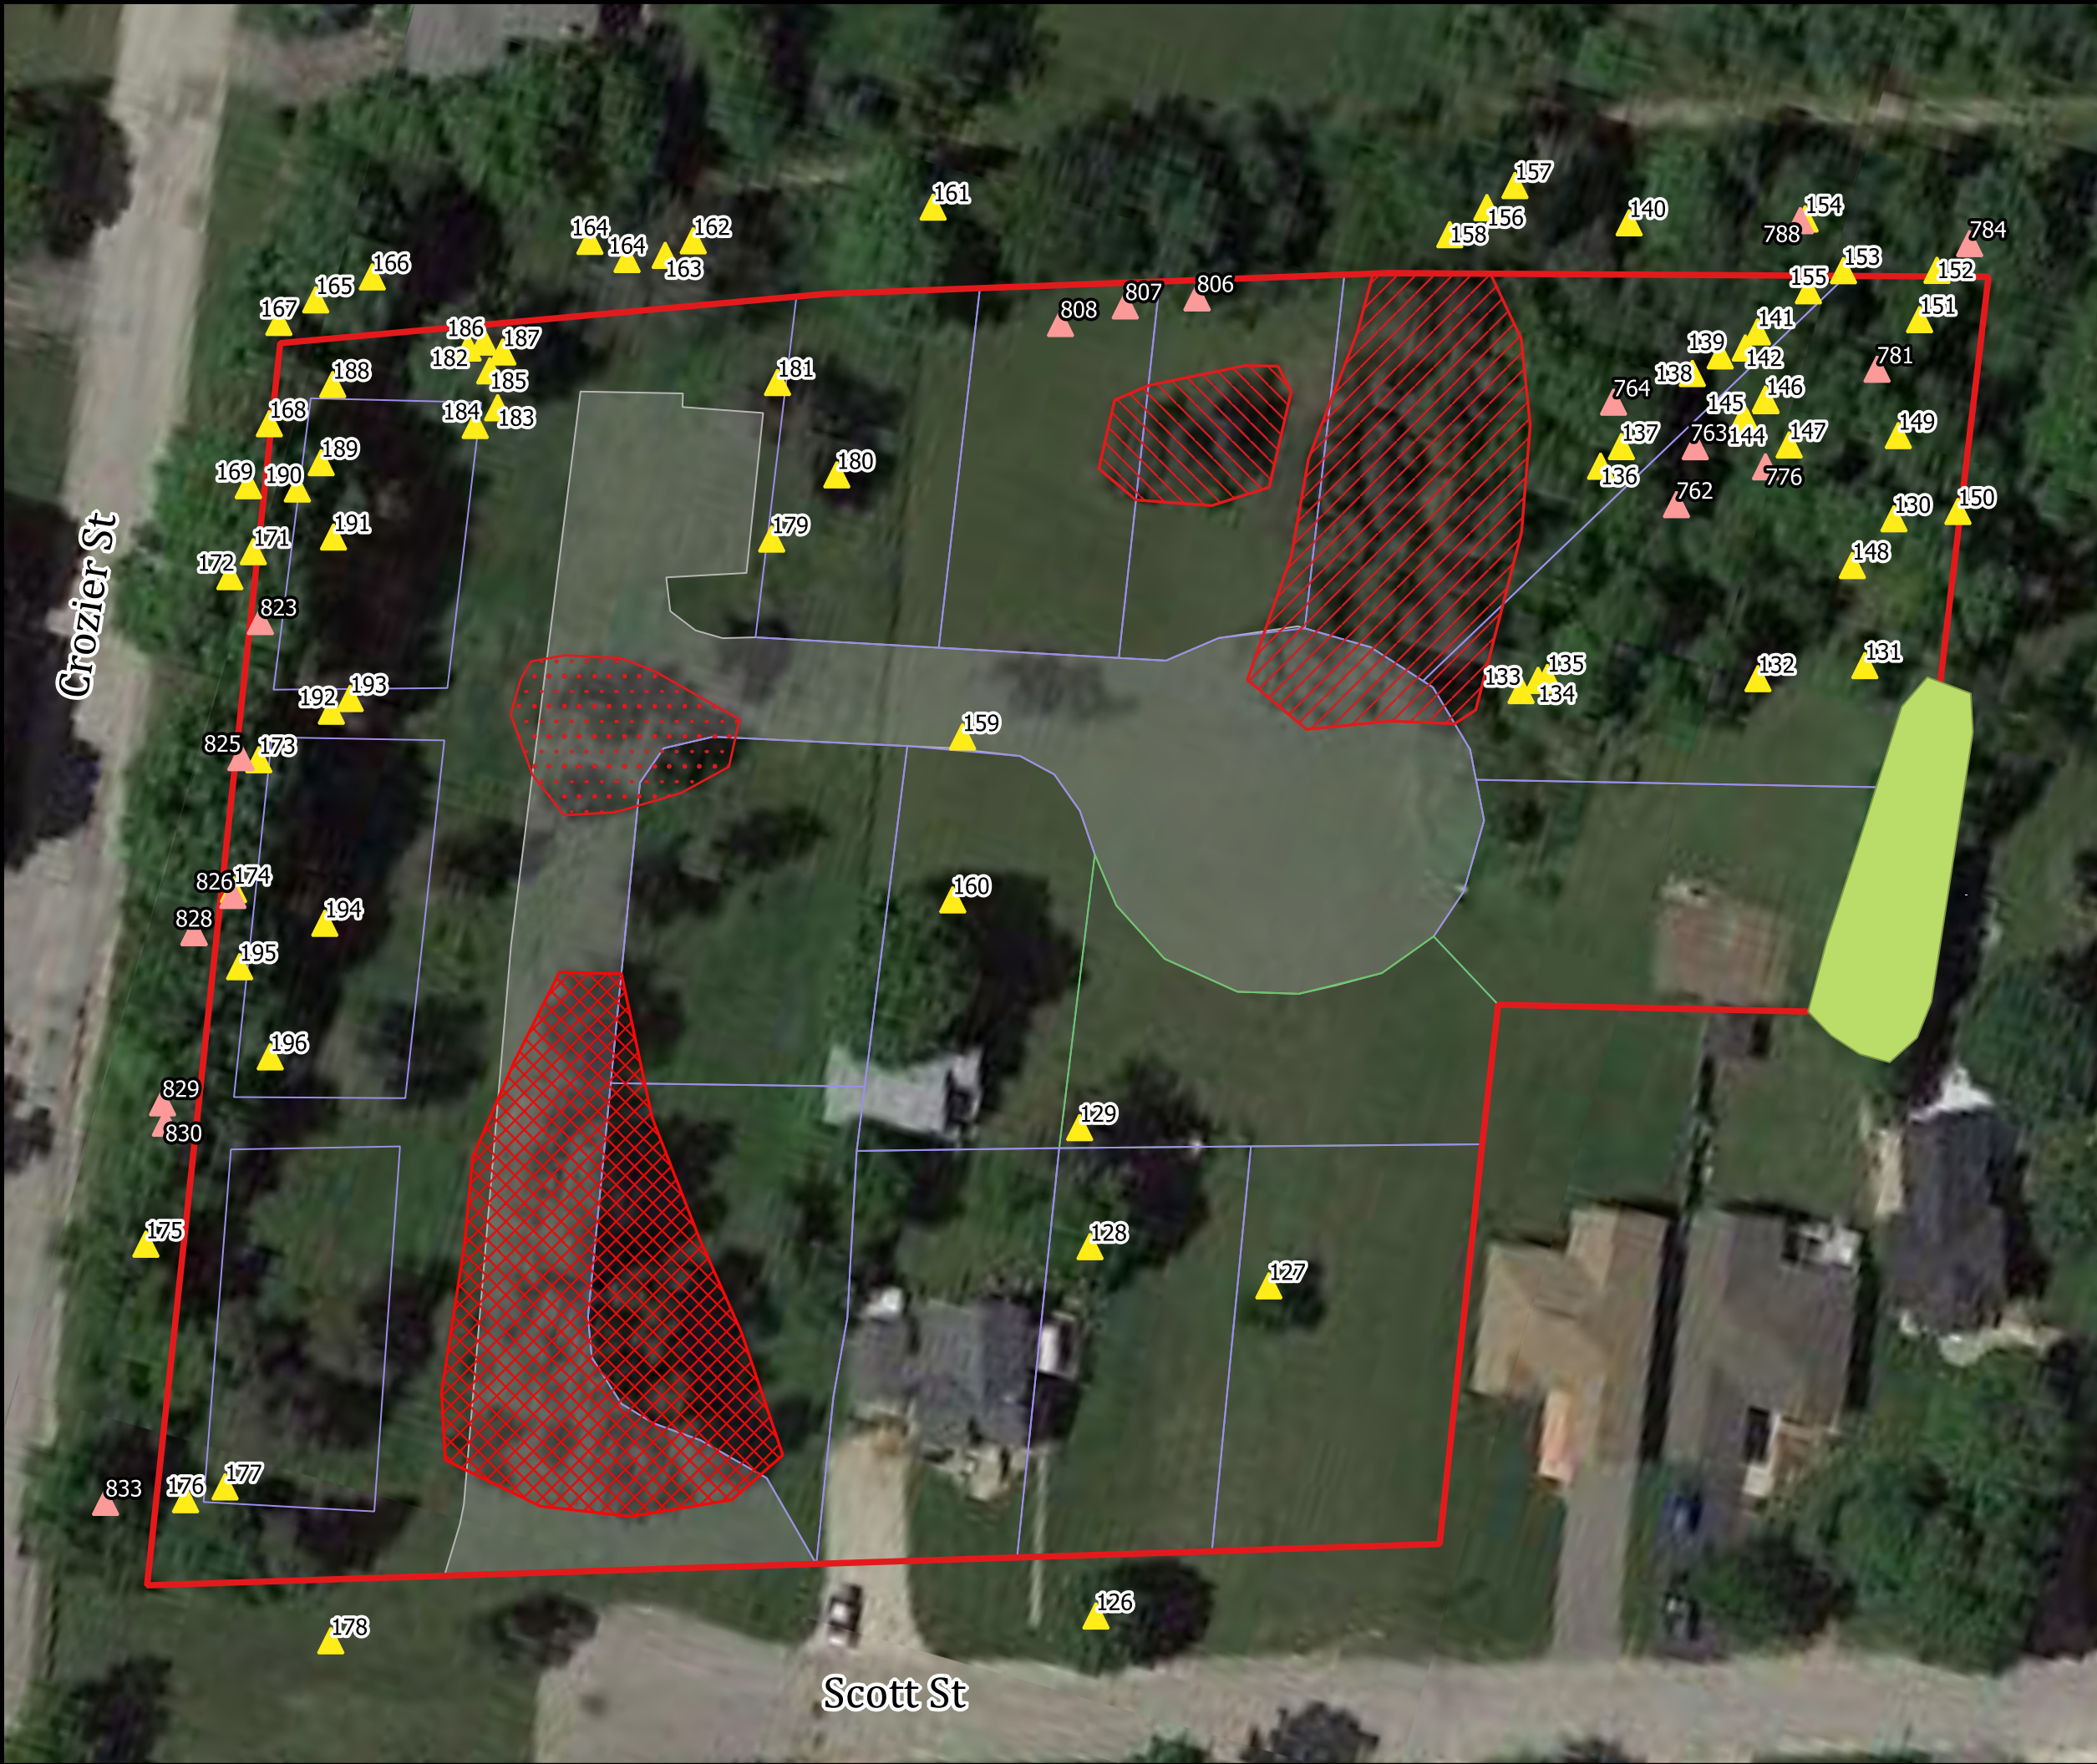
Appendix 4: Figure of Approximate Tree Locations and Approximate Development Plan

20 Scott Street Arborist Inventory

Accuracy is approximate for tree locations and proposed development
