Thomasfield Homes

Hydrogeological Study for Mayberry Hill Subdivision Phase 3B

GMBP File: 115049

March 2020

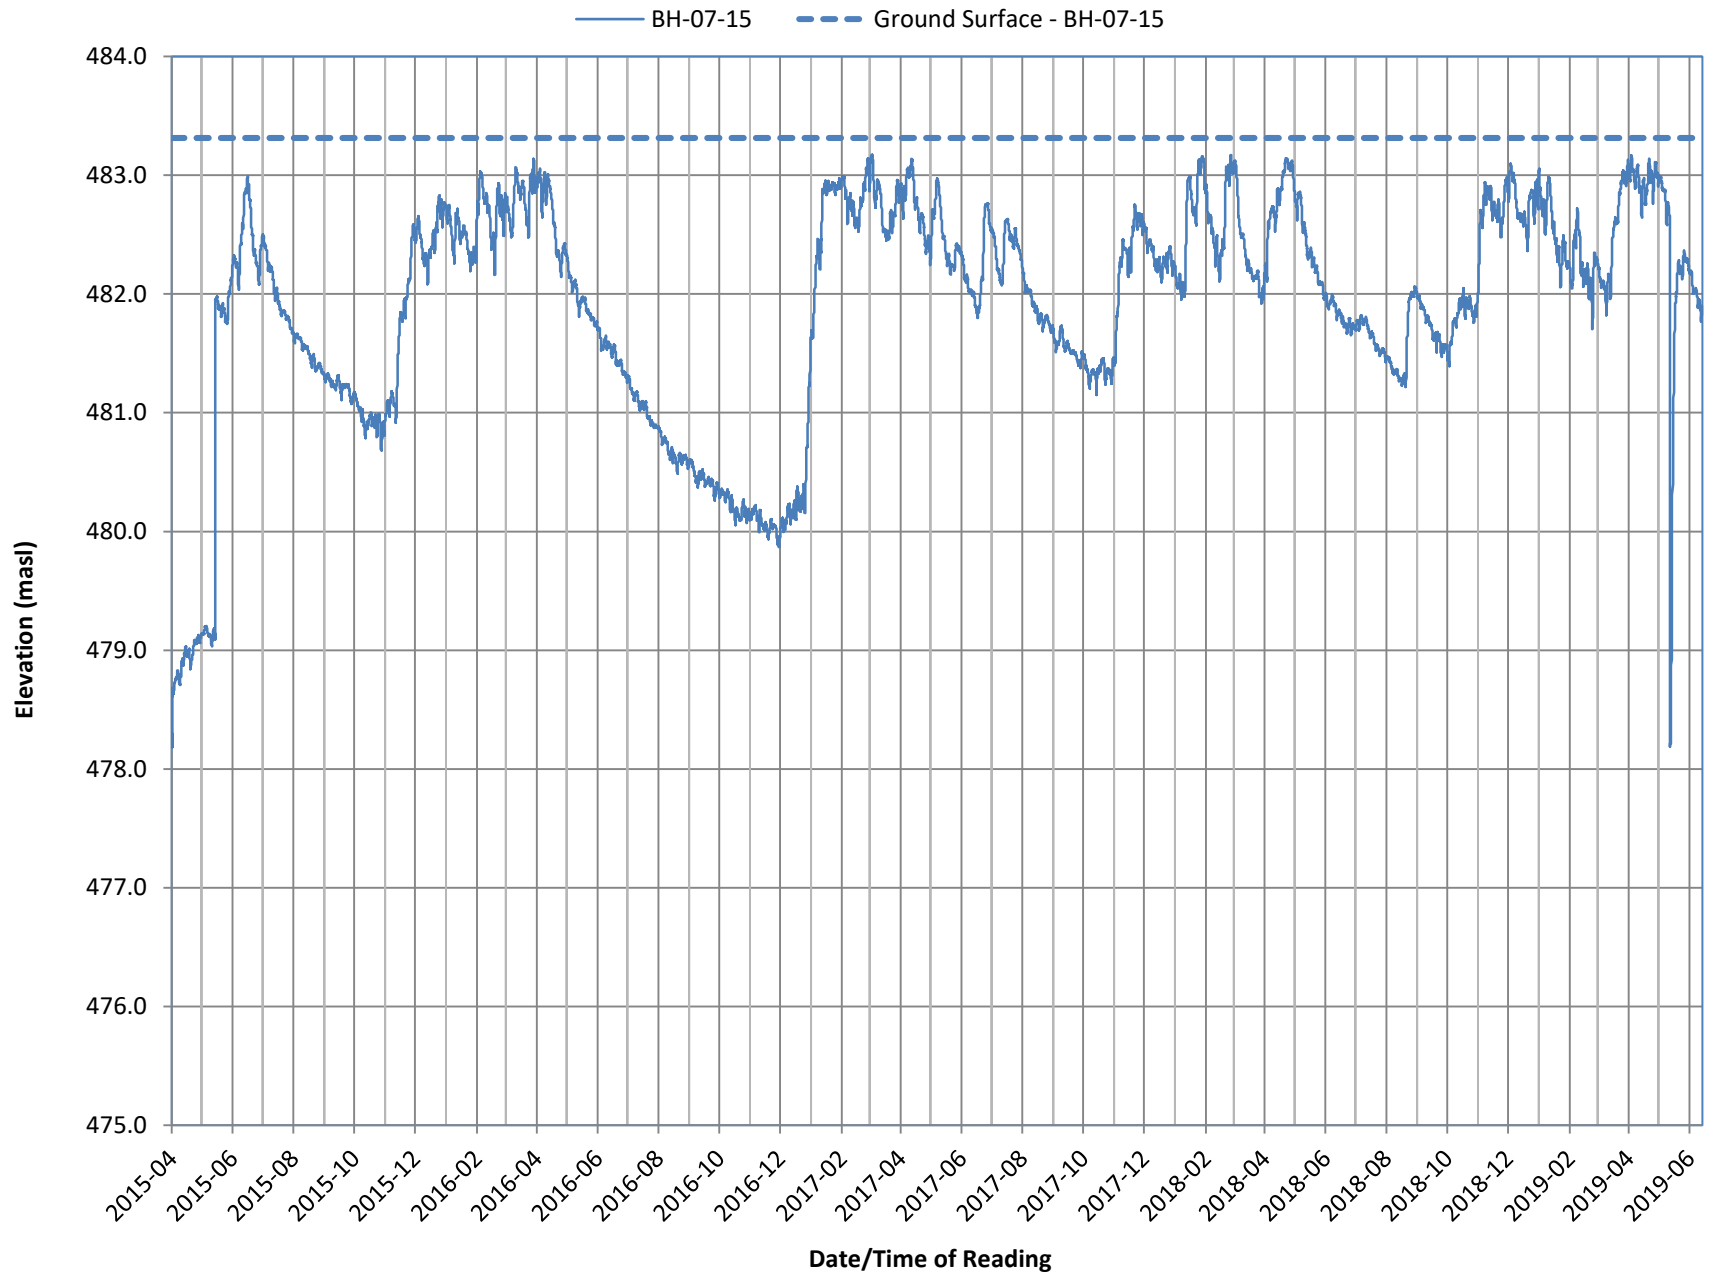
**APPENDIX E:
GROUNDWATER HYDROGRAPHS**

The portion of the Site proposed to be developed with houses exhibits significant seasonal fluctuations in groundwater level. This is interpreted to be a product of the fine-grained soils (which limit the rate of infiltration) and the effects of evapotranspiration, which is greatest during the summertime and lowest during the winter.

- Groundwater levels on-Site were observed to rise as high as 0.2 m below ground surface (mbgs) at BH-07-15, but at BH-04-15 it remained deeper than 4.0 mbgs.

The record of groundwater measurements has shown that groundwater levels have at times risen to be within 1 m of the surface in some parts of the Site (e.g. BH-01-15 and BH-07-15). As such, it is reasonable to expect that some form of protection against moisture intrusion into basements would be required.
